EarthTEC turns failures into success

RIVER & MARINE WORKS

REF No. E/EC- 0561T

Client: Glenorchy Council
Location: Humphrey's Rivulet, TAS
Project: Flood drainage remediation

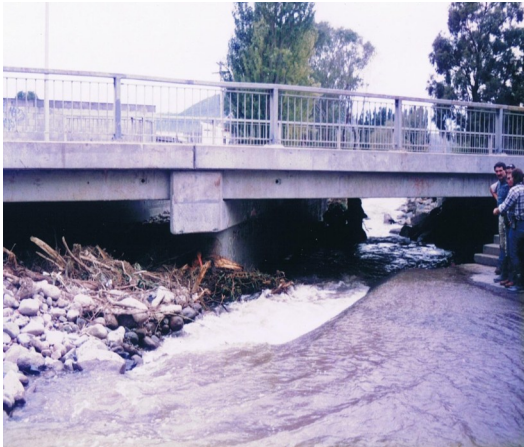
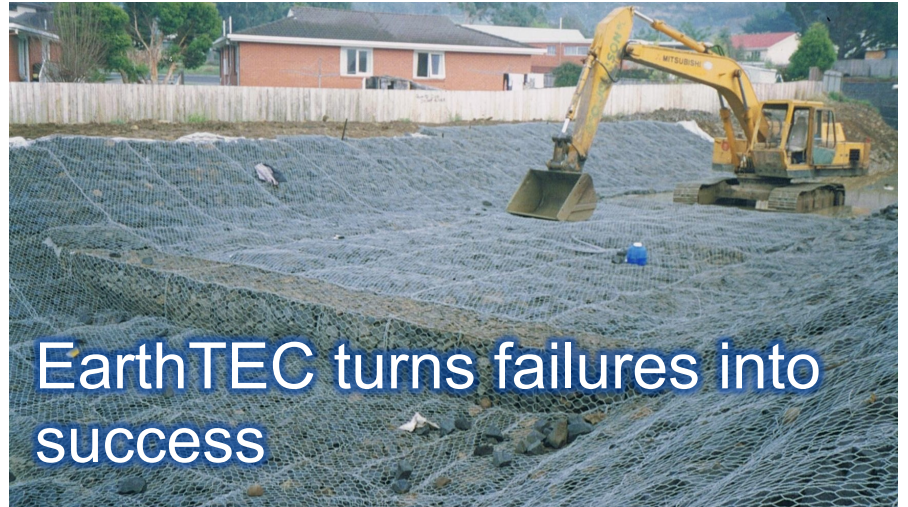
Unfortunately things didn't quite work, and many of the completed repair works were irreparably damaged in a subsequent flood.

On closer inspection it became apparent that the problem was not the gabion products, but rather the design detailing and installation techniques adopted.

EarthTEC's team got to work immediately and presented council with a design and construct solution.

Work on the repairs commenced immediately, and within two weeks the river bank was stabilised over a 60m section and the failure risk was averted.
